**Flood Control Project Maintenance  
Levee Inspections**  
**LMA District Cover Sheet**  
**Spring 2011 Levee Inspection Results**

**Merced Streams Group**

**Levee Inspection Report By Mile - Spring 2011**

Waterway						Bank	Unit Miles	Inspection Start/End	Inspector
Unit No. 01 Black Rascal Diversion						Right	1.64	05/05/2011 05/05/2011	Herman Phillips

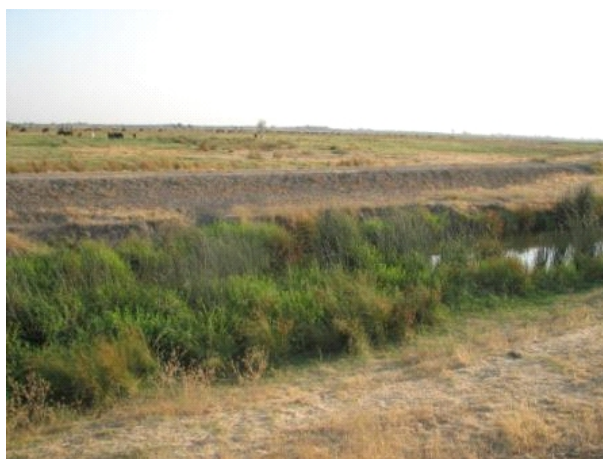
phillips\_s\_20110228\_185.jpg

Photo taken in 2007.

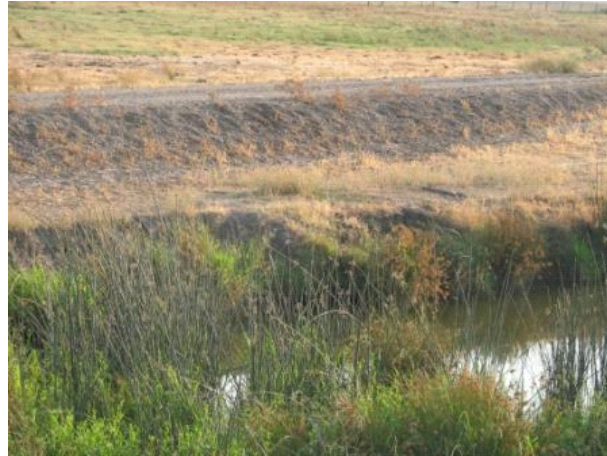
phillips\_s\_20110228\_186.jpg

Photo taken in 2007.

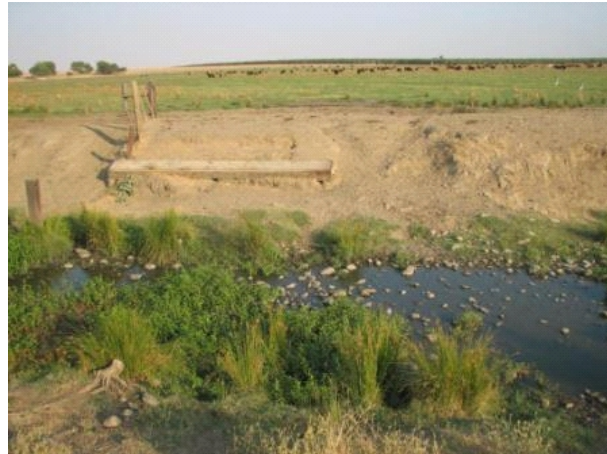
phillips\_s\_20110228\_181.jpg

Levee Mile Report Line	8
Start Levee Mile	0.42
End Levee Mile	0.43
Location	Water Side
Category	Supplemental
Item	DWR Erosion Survey

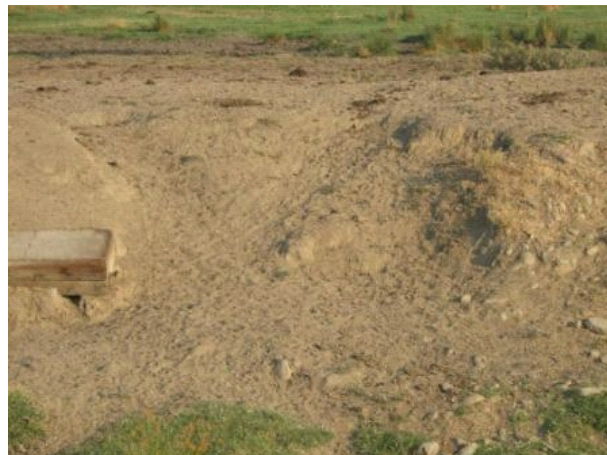
phillips\_s\_20110228\_182.jpg

Levee Mile Report Line	8
Start Levee Mile	0.42
End Levee Mile	0.43
Location	Water Side
Category	Supplemental
Item	DWR Erosion Survey

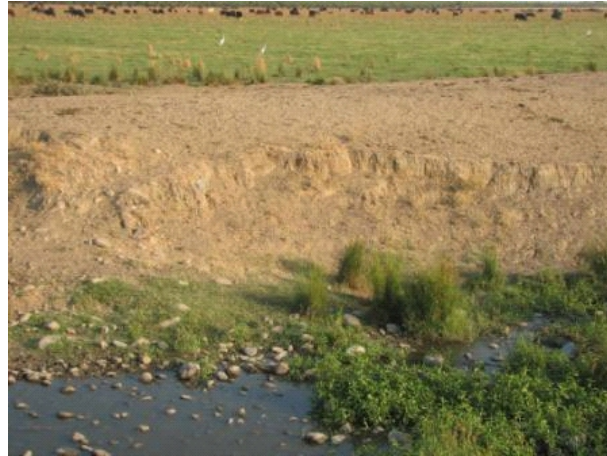
phillips\_s\_20110228\_183.jpg

Levee Mile Report Line	8
Start Levee Mile	0.42
End Levee Mile	0.43
Location	Water Side
Category	Supplemental
Item	DWR Erosion Survey

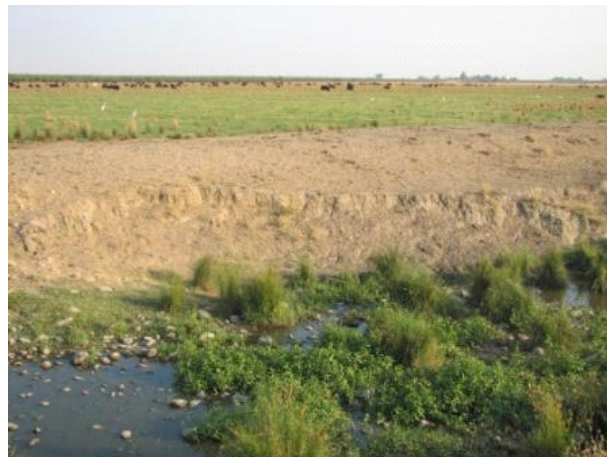
phillips\_s\_20110228\_184.jpg

Levee Mile Report Line	8
Start Levee Mile	0.42
End Levee Mile	0.43
Location	Water Side
Category	Supplemental
Item	DWR Erosion Survey
